**USE OF CT SCANNING IN THE INVESTIGATION
OF DAMAGE TO UNCONSOLIDATED CORES**

R. E. Gilliland - Mobil E & P US Inc. - New Orleans

M. E. Coles - Mobil Research & Development - Dallas

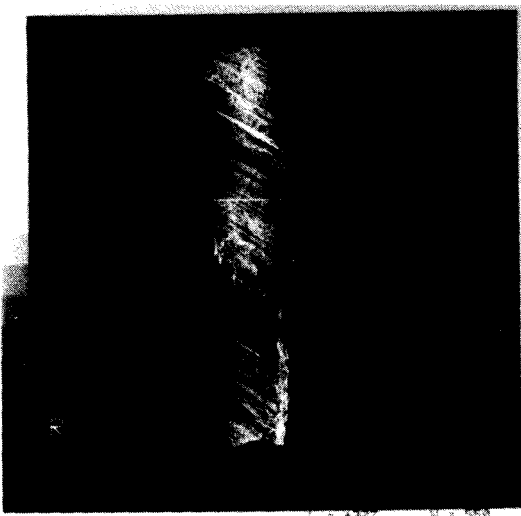
Evidence of bedding planes and other depositional features are sometimes visible from CT scans. A survview scan (figure 3) indicates this interval to be a finely laminated series of sands and shales. Remember that the density difference of the sand and shale material provides contrasting CT attenuation. Similar interpretative models can be made for almost any two substances with differing X-Ray absorption characteristics.

Figure 3. A surview scan indicates this interval to be a finely laminated series of sands and shales.

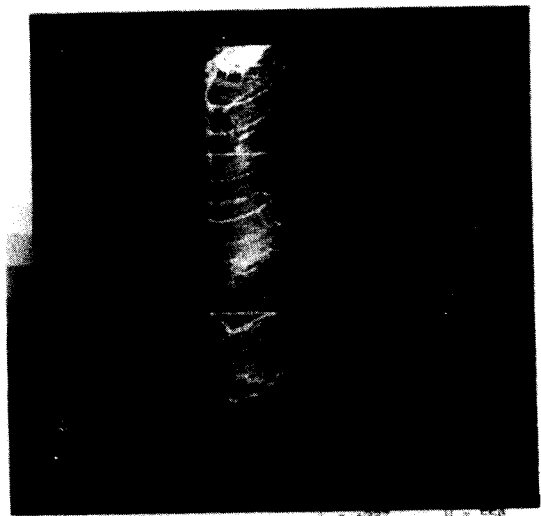
Figure 4. This surview of a section of core from a deviated well shows laminated beds which are highly dipping.

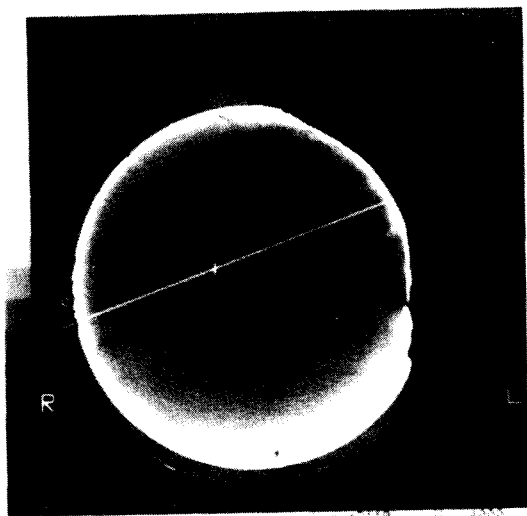
Recovered conventional cores are usually slabbbed longitudinally at an orientation which will reveal the maximum dip angle whether caused by deviation of the wellbore or natural tilting of the cored beds. This slab face is important not only in the study of depositional features, but also in the later plugging of the core to insure that the plug samples are taken parallel to the bedding. Since the cores usually arrive at the lab in an opaque inner barrel of PVC plastic or fiberglass, the direction of maximum dip must be determined by either opening the tubes for visual inspection or by CT scanning. This survview (figure 4) of a section of core from a deviated well shows laminated beds which are highly dipping. By examining a cross-sectional slice through the interval (figure 5), the laminations can be oriented properly for slabbing.

Figure 5. By examining a cross-sectional slice through the interval, the laminations can be oriented properly for slabbing.

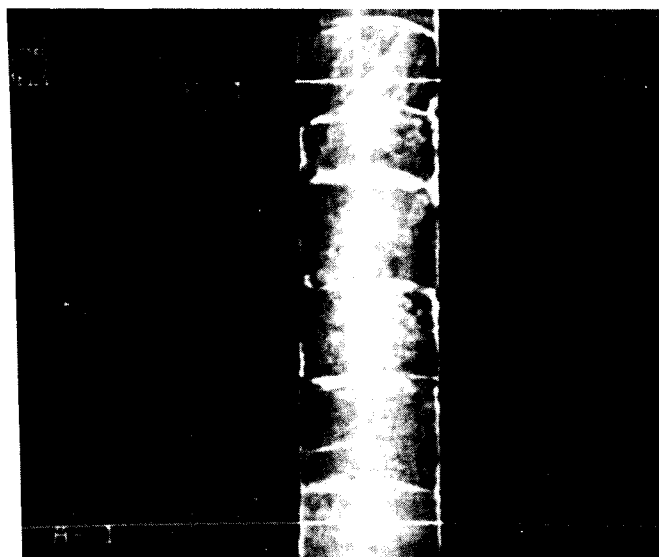
Occasionally the CT scan can reveal subtle differences in bedding features in addition to the normally evident structural relief. In this example, the surviue (figure 6) apparent dip of the formation beds in the small section of the core near the top is quite steep, however the breaks across the core are horizontal, suggesting that the sand and shale beds have very little structural dip. The apparent dip in this upper small sand interval is due to cross bedding in the formation and not structural dip. A slice (figure 7) through the crossbedded section reveals numerous light and dark stripes indicating cross beds in the core.

Figure 6. The apparent dip of the formation beds near the top is quite steep, however, the horizontal breaks across the the core suggest little structural dip.

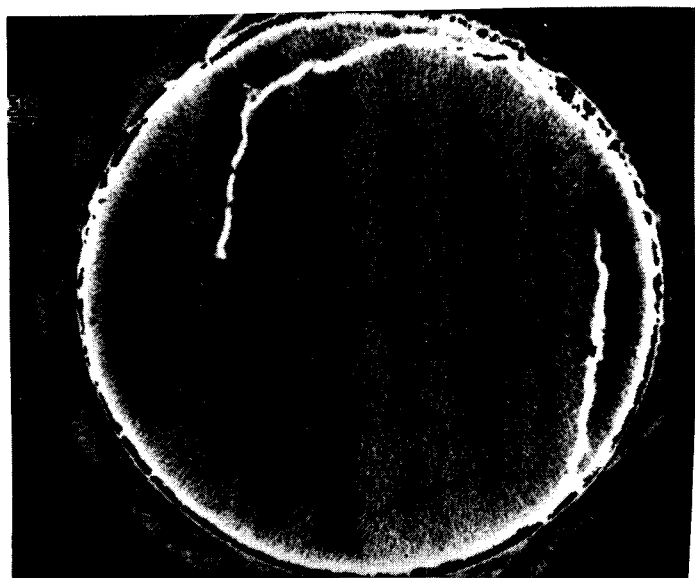
Figure 7. A slice through section reveals numerous light and dark stripes indicating cross beds in the core.

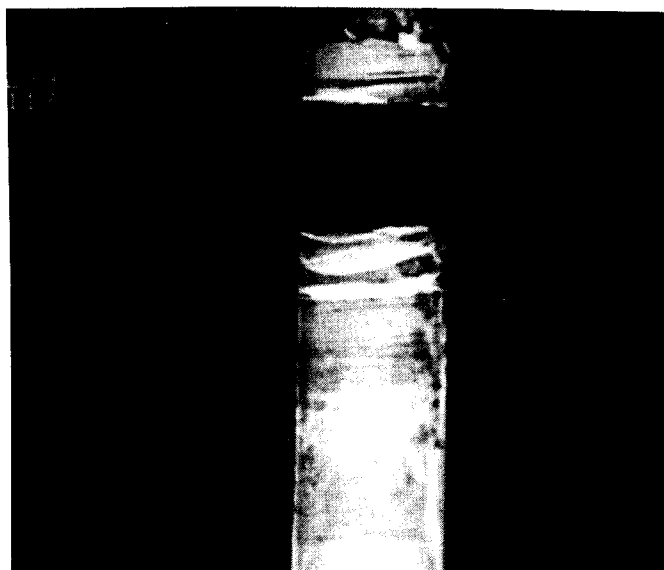
Figure 8. This surview shows a dark area in the upper portion of the core.

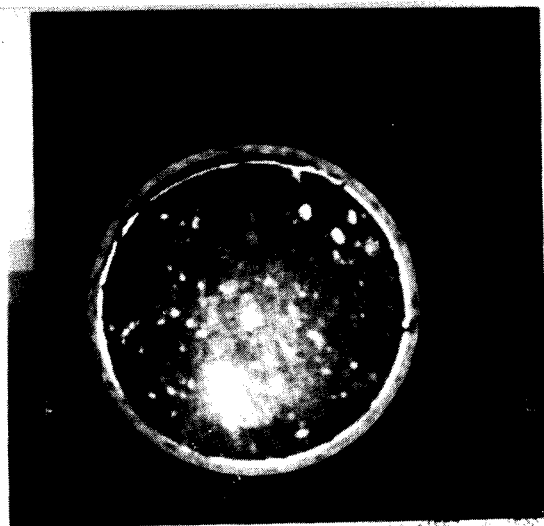
The selection of samples for certain types of analysis requires that they be representative of the majority of the formation and free of any unusual mineral inclusions. Some type of nondestructive internal inspection is very useful in selection of those samples. A slice scan (figure 10) through a section of core being considered for special core analysis work reveals a number of bright spots apparent in the core. Further analysis of the interval revealed these to be shell remains imbedded in the core. Not only is this information important stratigraphically, but such inclusions can cause errors in laboratory measurements and misapplication of results if they are prevalent but undetected. If mineral inclusions and selective cementation are common throughout the core, the decision to make some measurements with whole core sections to average in the effect of this heterogeneity may be necessary to accurately represent the reservoir.

Figure 10. A slice scan through an area for special core analysis reveals shell remains imbedded in the core.

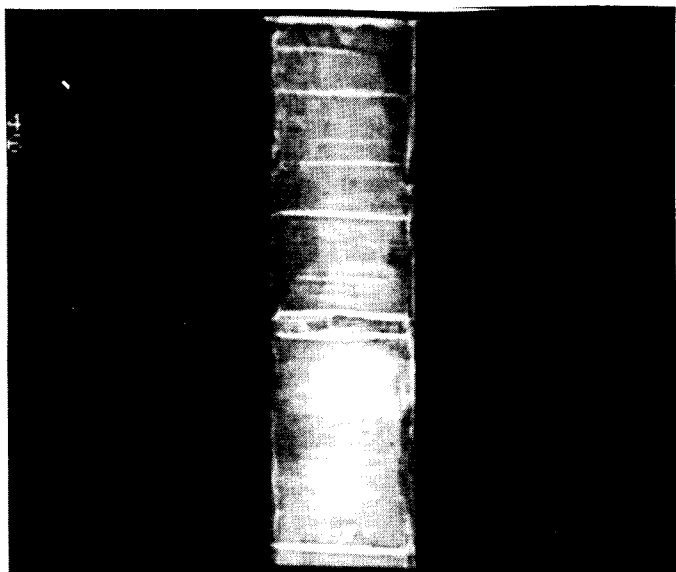
The most frequent alteration of the core is mechanical separation with accompanying mud invasion. This longitudinal or surview scan (figure 11) of a core section typifies the separation of a laminated sand-shale sequence at the shale boundaries. Inspection of the slabbed core from these sections usually confirms that the core indeed separated at a sand shale interface rather than within the shale itself. Separations of this type are more common in thinly bedded sands and shales rather than in thicker, more structurally stable shale beds. Invasion of barite weighted drilling mud into the cracks (shown here as the bright lines across the core) suggests that this separation occurred downhole during the coring operation. Prevention of this type of damage is very difficult due to the fact that the material is so fragile.

Figure 11. This surviev scan typifies the the separation of a laminated sand-shale sequence at the shale boundaries.

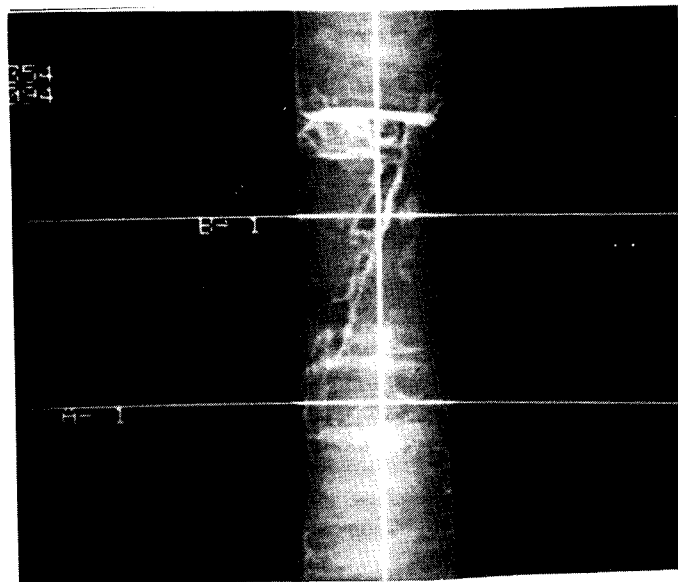
Cases of mechanical damage are often seen when inspecting recovered cores. In this series of scans a shock induced fracture is shown in the core. The surview scan (figure 12) identifies a fracture running diagonally across the center portion of the section. Slice views at points A-1 and B-1 were taken to ascertain if the apparent surface crack ran through the core. Slice A-1 (figure 13) taken below the disturbed area shows a homogeneous section of sand with very little damage evident except on the fringe of the core. However, slice B-1 (figure 14) reveals that the fracture indeed traverses the core. The mud invasion pattern shown by the partial filling of the crack with mud indicates that the damage occurred at or very near the surface. Subsequent inspection of the slabbed core revealed that the fracture was indeed caused by the coring and was not a natural fracture or fault. The diagonal nature of the fracture indicates a slump failure possibly caused by the weight of the core and was triggered by rough treatment of the core during surfacing or while in the vertical position on the rig floor.

Figure 12. The surviev scan identifies a diagonal fracture across the center portion of the section.

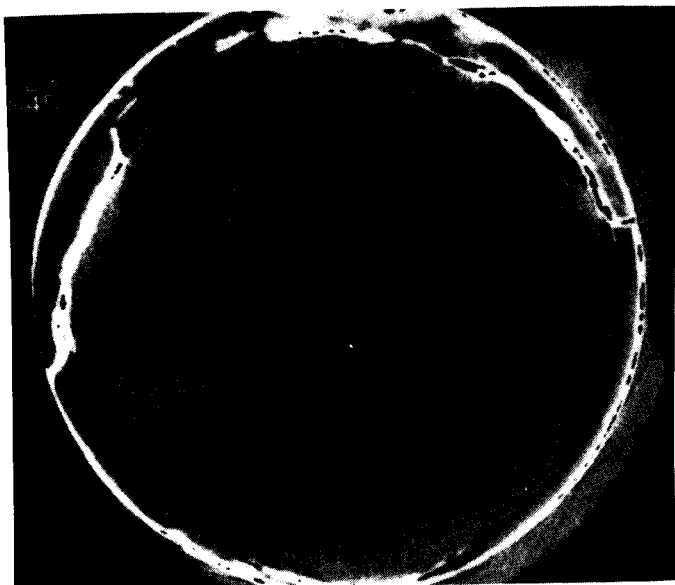
Figure 13. Slice A-1 taken below the disturbed area shows a homogeneous section of sand with little damage except on the fringe of the core.

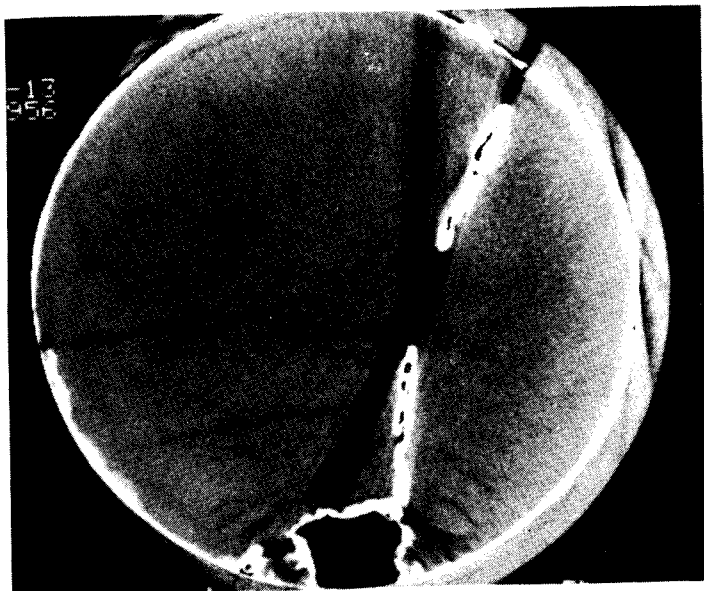
Figure 14. Slice B-1 reveals that the fracture tranverses the core.

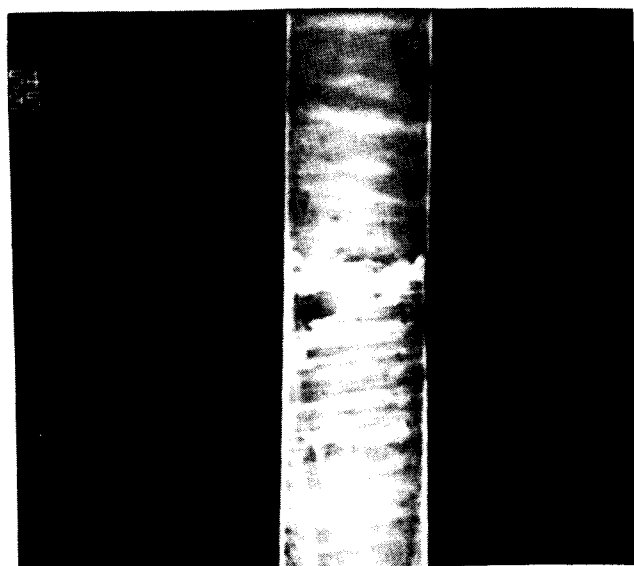
There are a number of mechanical shocks and torque stresses applied to the core as it is being cut. These sometimes cause the core not only to break but also to rotate in the inner barrel. A surview scan (figure 15) of this core interval shows apparent bedding planes dipping from left to right across the upper half of the section. However, note that below the sharp bright line about midway down the section, the apparent dip reverses, indicating a change in orientation of the core inside the barrel. The rounding of corners of the core material just above and below the break, probably due to some erosion of sand as the core turned also suggests spin as opposed to some natural event. A slice taken through the break area (figure 16) shows mud invasion deep into the core. Inspection of the slabbed core confirmed this diagnosis and ruled out the possibility of an unconformity here.

Figure 15. A surview scan of this core interval shows a sharp bright line indicating a change in orientation of the core inside the barrel.

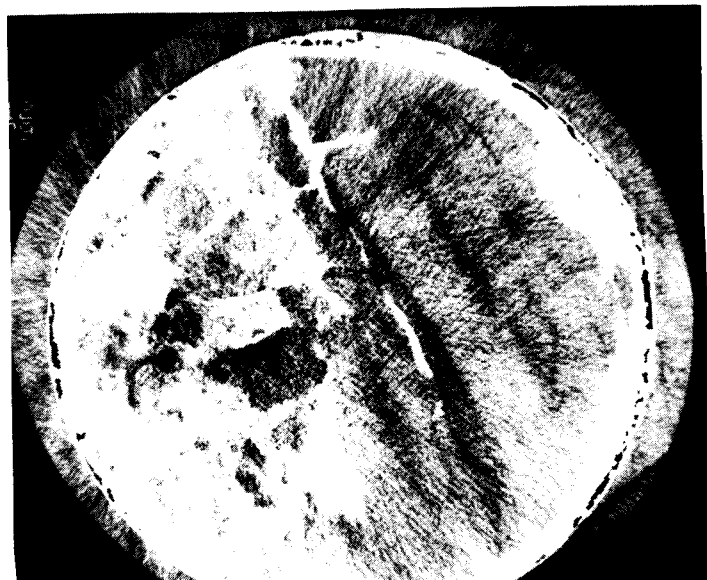
Figure 16. A slice taken through the break area shows mud invasion deep into the core.

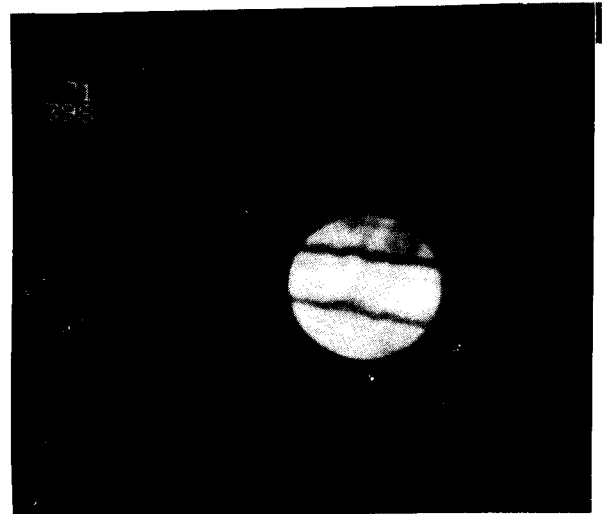
In order to obtain parameters for reservoir properties from a core, plug samples are generally taken for cleaning and quantitative analyses. It is imperative that these plug samples reflect the reservoir as accurately as possible, both in representation of the reservoir character and in quantitative results. Taking plugs in unconsolidated cores is difficult at best and sometimes results in serious damage to the plug sample and the remaining core. An end view scan (figure 18) of a core plug taken from a section of laminated sand reveals two fractures in the plug across its face. Note that a side view of this sample (figure 19) shows the fractures traverse the entire length of the plug. Although these fractures may be closed up by the addition of simulated overburden pressure, the resultant analyses may be inaccurate and should not be used for precise quantitative comparisons.

Figure 18. An end view scan of a core plug taken from a section of laminated sand reveals two fractures in the plug.

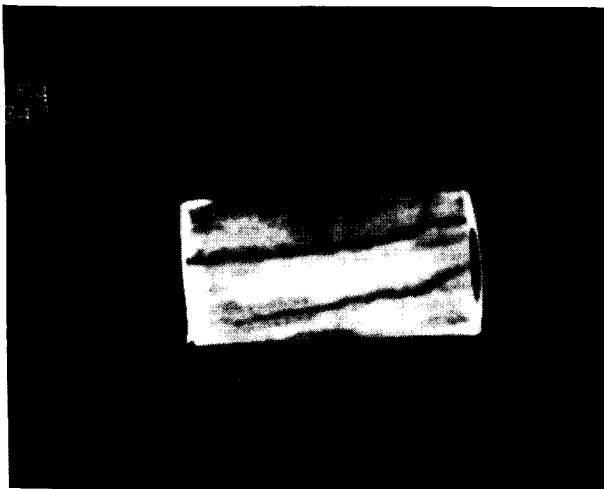
Figure 19. A side view of the sample in figure 18 shows fractures traverse the entire length of the plug.

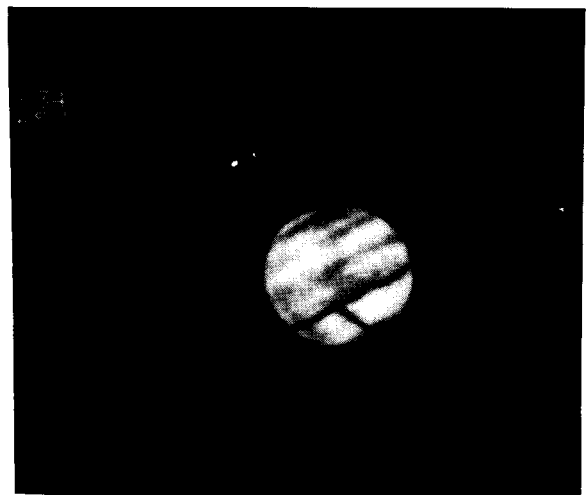
A second plug example shows damage not only along the plug lengthwise (figure 20) but also partially across the core as well (figure 21). This combination of fractures make the plug unsuitable for any analyses involving flow characteristics.

Figure 20. An end view scan of a core plug taken from a section of laminated sand reveals fractures in the plug.

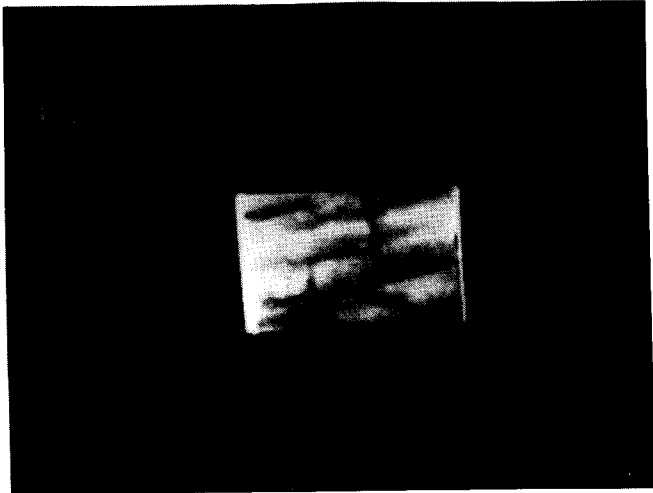
Figure 21. A plug example shows damage along the plug lengthwise and partially across the core.

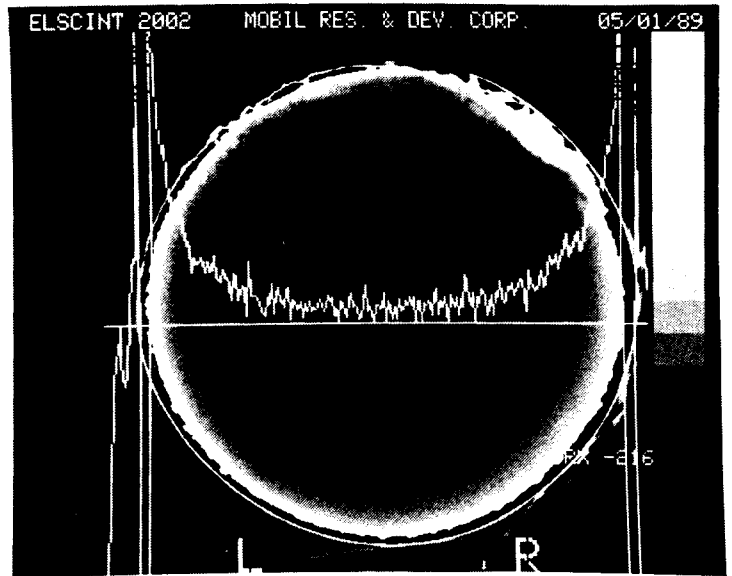
The invasion of mud filtrate and especially mud solids into cores represents a common and often serious problem in the subsequent analysis of the core. The use of the CT scan is an invaluable aid in detecting the presence and location of such damage. This slice view (figure 22) of a core shows the bright signature of barite weighted mud invading deeply into the core. A profile of CT numbers is shown across the slice. Since the CT number is directly related to material density, and assuming a fairly homogeneous local sand density, the mud invasion is shown graphically. Closer inspection of these damaged areas revealed both mud filtrate and, more seriously, mud solids have invaded in some cases. These mud particles are difficult to clean from the core and will cause inaccuracies in subsequent core analysis work. The best cure in this case is obviously prevention of the invasion if possible by the use of face discharge coring bits and low fluid loss mud systems. Lost circulation material can be added in some cases to aid in this effort.

Figure 22. This slice view shows the bright signature of barite mud invading deeply into the core and a profile of CT numbers across the slice.

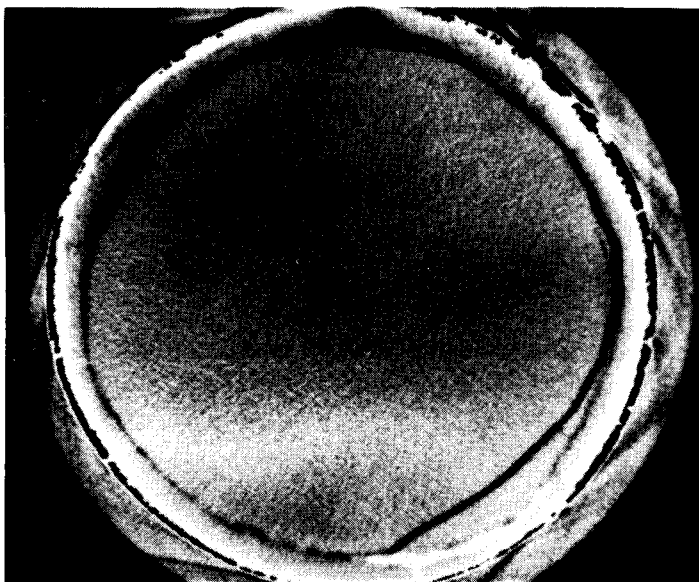
One of the more common occurrences of damage to sections of clean, massive unconsolidated cores is that of concentric fracturing or separation inside the inner barrel. This deterioration is thought to be a result of freezing, transportation shock, torque applied while coring or a combination of all these factors. Very little evidence of radial fractures has been found at the rig site by visually inspecting tube ends of the three feet sections of recovered material. Close inspection of mud invasion and fluorescence patterns show that in most cases, the separation point coincides with the depth of mud invasion (figure 23). Since the mud filtrate is water and is replacing mostly hydrocarbons in the invaded zone, it provides a cement to hold the sand together as it is frozen, whereas the oil or gas saturated portion of the core

does not freeze as completely or at the same rate. In core sections which were originally water wet in the formation, the concentric separation tends to be less severe or not present. However, some samples have been observed to exhibit this type of failure having never been frozen, suggesting that torque on the sample while it was being cored followed by transport shock may have caused the damage. Again these samples were oil saturated in situ and invaded by fresh water drilling mud.

Figure 23. Close inspection of mud invasion and fluorescence patterns show that the separation point in concentric fracturing coincides with the depth of mud invasion.
